E5515C-14

S E R V I C E N O T E

E5515C Wireless Communications Test Set (8960 Series)

2 Missing Washers on the DSP Fan Assembly Requires Replacement of the 5.8 DSP Board

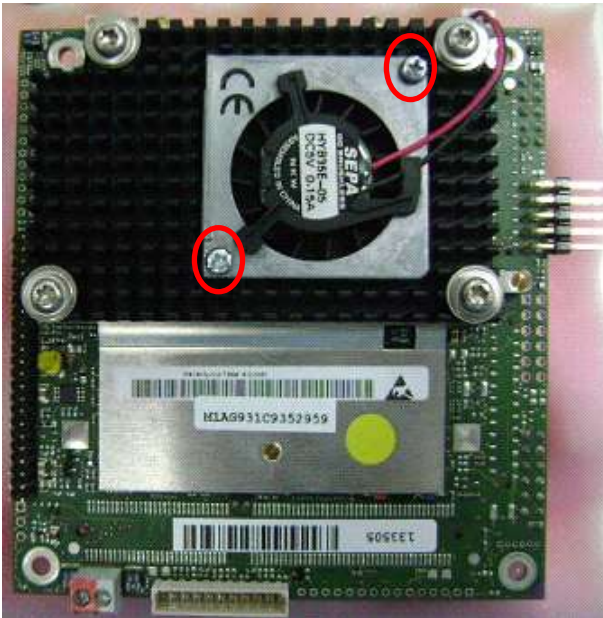
Figure 1: Washer locations

The two washers are located on the DSP fan assembly as shown in the picture below. The washer sits in between the screw head and fan assembly metal work.

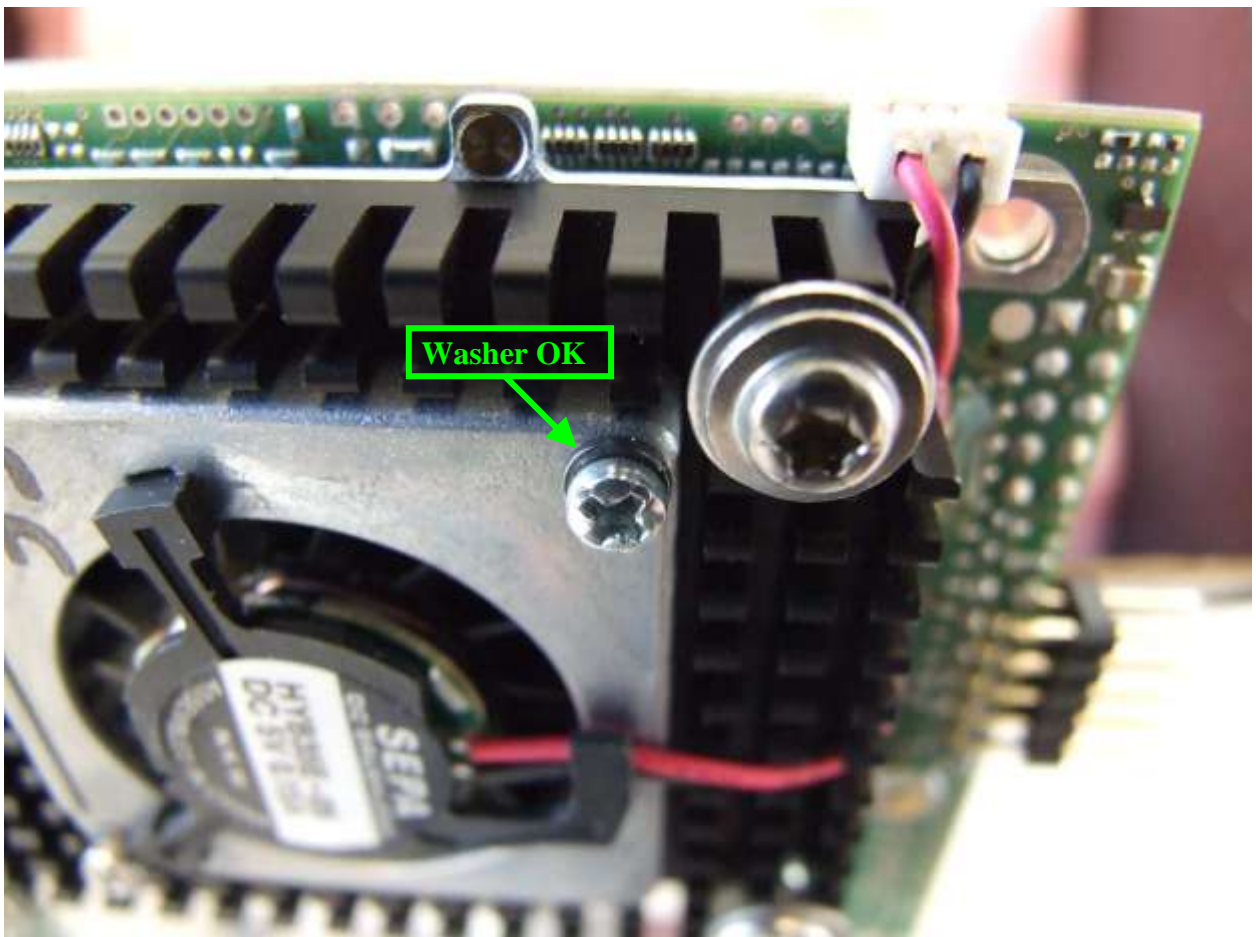
Figure 2: Washer is present

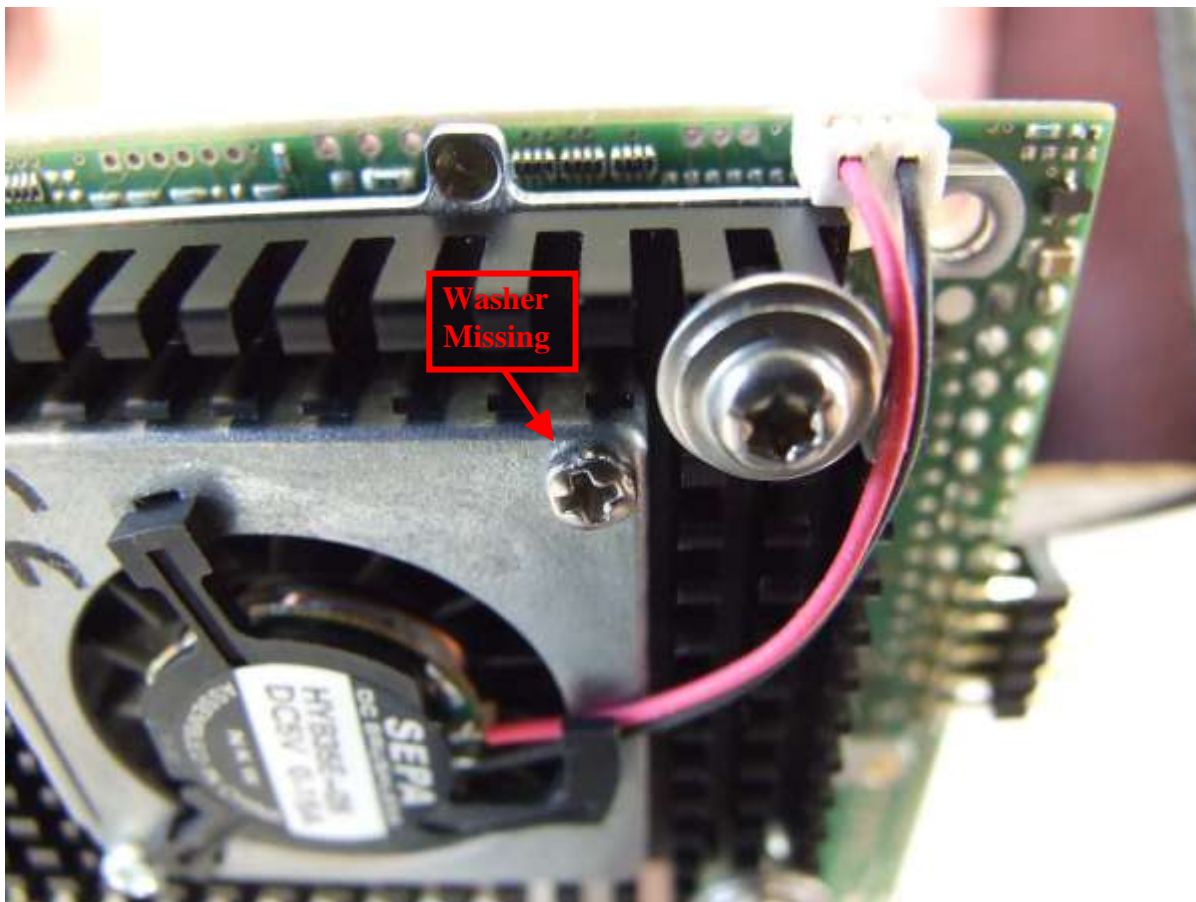
Figure 3: Washer Missing

Without the washers, the screws bottom out and lift the heat sink from the sheet metal below, causing an air gap, less cooling effect and therefore a hotter running DSP which will eventually fail.

If the 5.8 DSP fan does not have the washers, replace the DSP Assembly using the repair kit E5515-61845. Verify that the test set boots up and operates normally. Re-calibration is not required.
