The focus of this technical note is to provide a guide to address PCI/PCIe communications issues if they occur while using the Agilent AXIe or PXIe chassis products with external PC controllers.

OVERVIEW

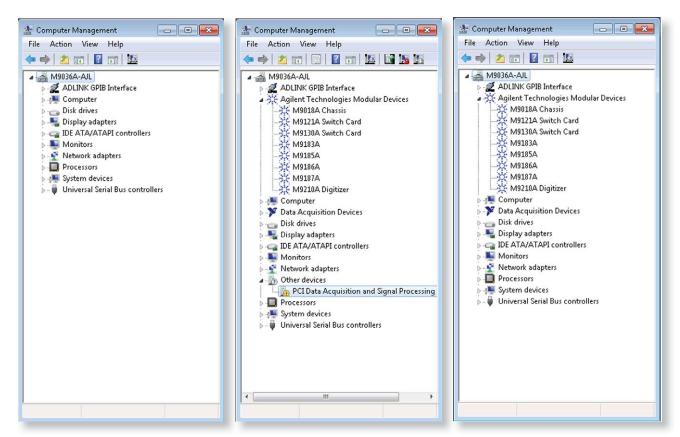
Figure 1a. Windows Device Manager does not show chassis or modules even after verifying chassis is properly cabled to controller.

Figure 1b. Windows Device Manager shows only some modules and/or the modules appear with a yellow icon.

Figure 1c. Windows Device Manager shows all modules and device (instrument) drivers are installed correctly.

This guide will be helpful if the chassis and some or all of the modules are not present and viewable in WDM (Figure 1a). In addition, this guide will discuss situations where a yellow icon appears next to the PXI module(s) as it appears in WDM (Figure 1b).

This guide is not usually helpful if the all the modules are viewable in WDM (Figure 1c). The correct appearance in WDM indicates the instruments are present on the PCI bus and the instrument drivers are installed. If this is the case, verify the Agilent I/O libraries are installed correctly --www.agilent.com/find/iosuite --and then verify instrument communications using the soft front panel (provided with the instrument driver). Consult the instrument specific documentation for further debug assistance if needed.

A yellow icon next to the PXI device as shown in WDM (Figure 1b) may result from either a missing or corrupt instrument driver or limited PCI resources. Inspecting the error code will give additional information on the root cause. Double click on the device showing the error and view the Device status window (Figure 6). There are many device status codes, but the most common codes associated with chassis communications are 12, 28 and 31.

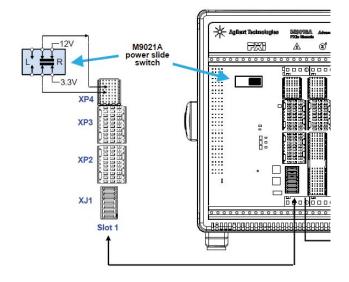
Figure 4. Backplane switch—M9021A power slide switch—must be set correctly (M9018A only).

Inspect the blue LED's DS301 and DS501. They must be lit indicating power is applied to M9021A. If the blue LED's are not lit, set power switch as shown in Figure 4.

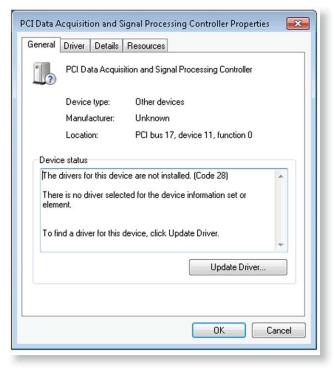
Figure 6. Windows Device Manager error code.

- · Code 28: The drivers for this device are not installed.
- Code 31: This device is not working properly because Windows cannot load the drivers required for this device.

Code 12: This device cannot find enough free resources to use.
